RONDOUT TUNNEL PROJECT

TUNNEL CONSTRUCTION PROJECT

Project Name	Rondout Tunnel Project
Client	New York City Environmental Protection (NYC DEP)
Main Subcontractor	Kiewit/Shea JV
Location	New York, USA
Product	Access Chambers
Total Tonnage	335 MT
Delivery Date	2018

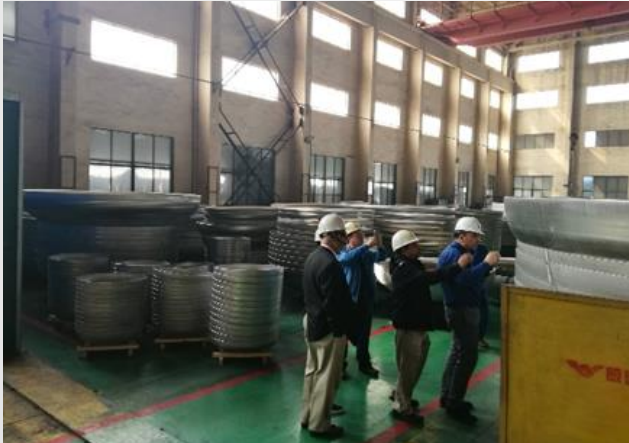
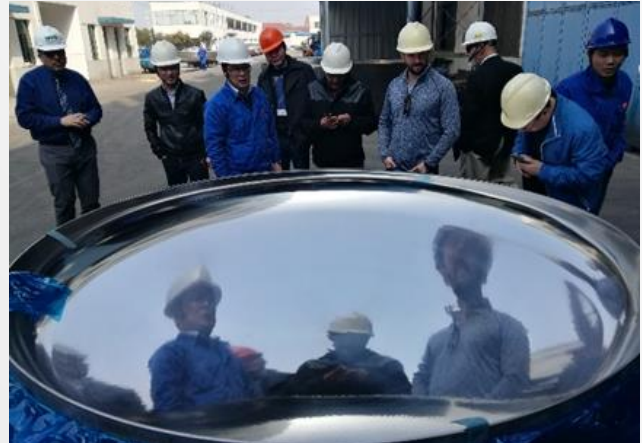
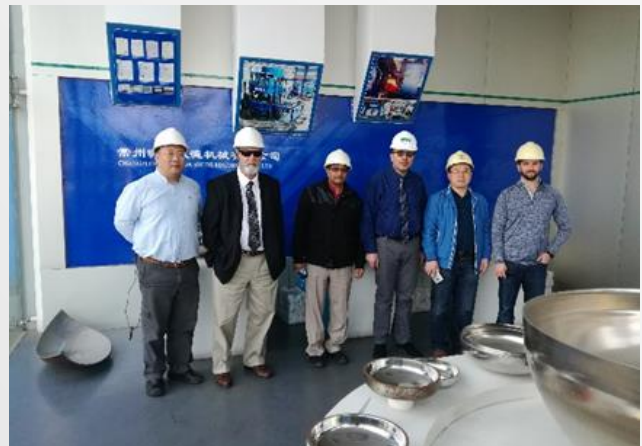
CLIENT AUDIT

Client representatives from NYC DEP and Kiewit performed supplier audit prior to the commencement of the project. The scope of this audit included the main fabricator's facility and other components supplier's facilities (shaft cap, flange, transition fitting, access pipe, stud and nut, and O-ring).

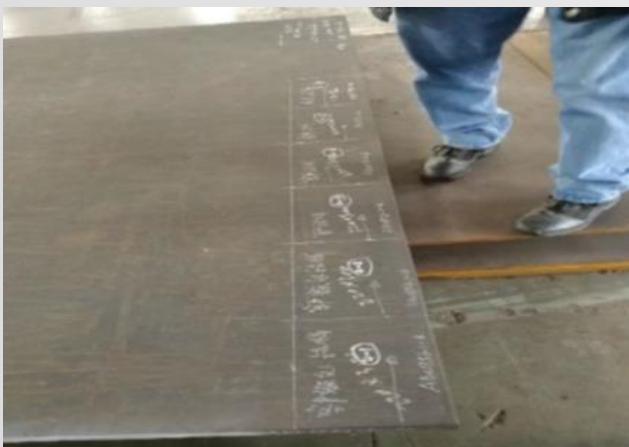
An inspector from NYC DEP and ESC own QA/QC staff were based in the workshop to witness the entire fabrication process from incoming raw material inspection to the painting process.

Samples are cut from each material to perform in-house mechanical properties and chemical composition retest for each heat number.

A 100% lamination ultrasonic test is performed on each material (flanges and steel plates).

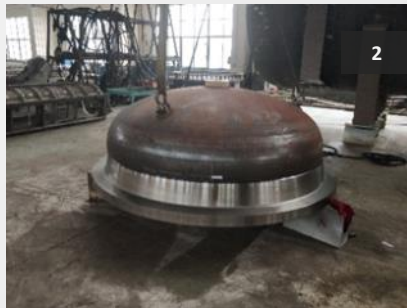
Picture 2 – Shaft cap welded with accessories (lifting lug & shaft cap insert) and tack welded with flange.

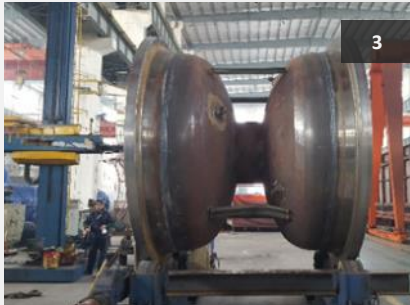
Picture 3 – Welding of shaft cap with flange

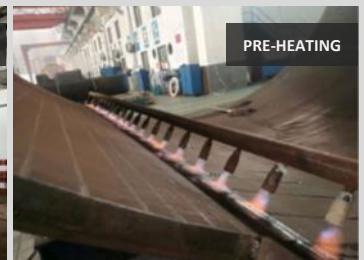
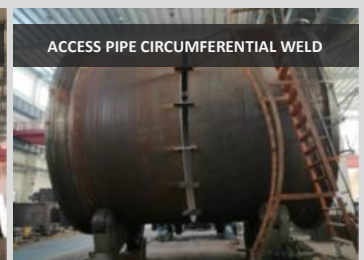
POST WELD HEAT TREATMENT

Each part of the access chamber (shaft cap, transition fitting, and access pipe) are heat treated separately after the welding process.

Each part is braced before the heat treatment process to prevent deformation.

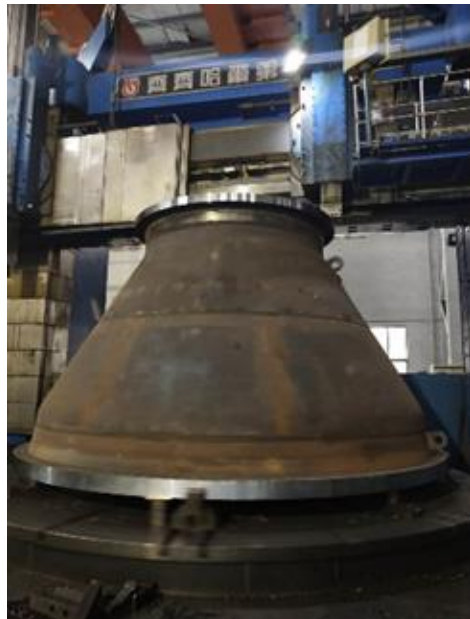
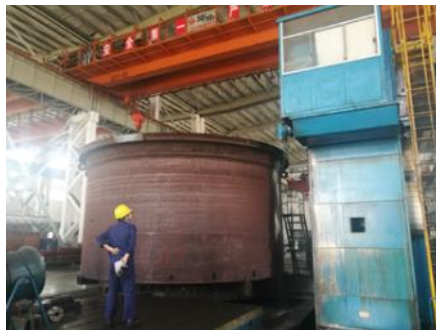
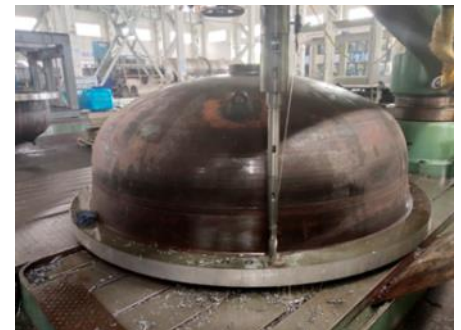
The flange face is machined to achieve the surface roughness requirements of $R_a = 0.8\mu\text{m}$ (for O-ring groove seating surface), $1.6\mu\text{m}$ (for O-ring groove wall), and $3.2\mu\text{m}$ (flange sealing face) in accordance with ASME B46.1.

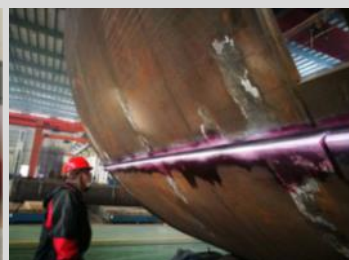
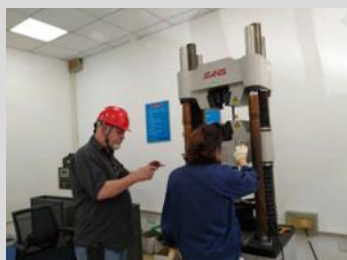
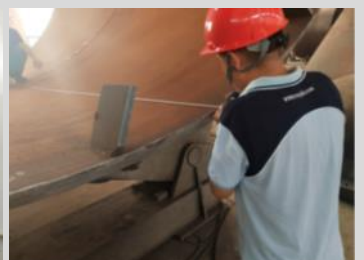
INSPECTION

1. 100% RT performed on all full penetration welds.
2. 100% PT performed on root pass after back gouging for butt welding.
3. Perform PT and thickness inspection on surface where temporary attachment are cut removed.
4. Perform mechanical test using the welding test plate prepared during actual production.

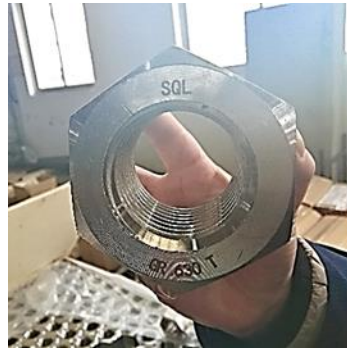
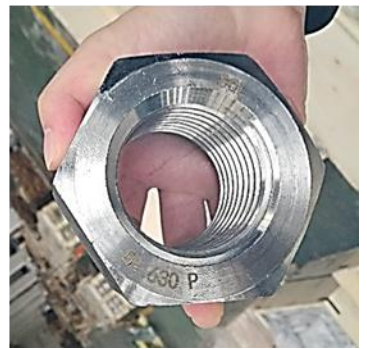
All studs & nuts are tightened using a hydraulic torque wrench.

The required stud & nut tension force for ID108" flange is 72,000lbf and for ID216" flange is 110,000lbf.

calibrated using a Skidmore Wilhelm Model K-100 before the stud and nut are assembled.

All studs and nuts are tightened using multi-pass tightening torque at 50%, 80%, and 100% final target torque. The studs and nuts are tightened according to the star pattern. Thread of the studs are lubricated with molybdenum disulphide grease prior to tightening process.

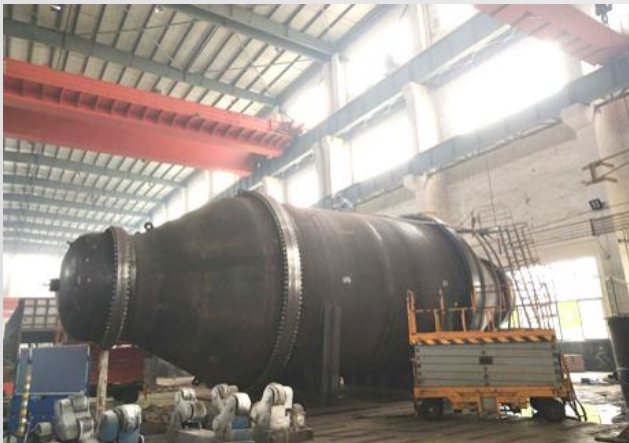
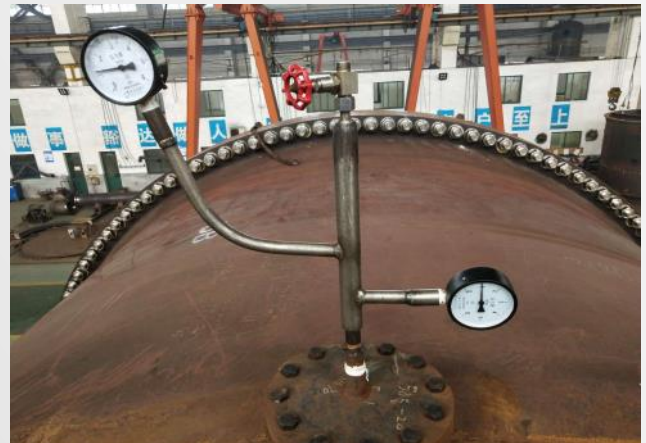
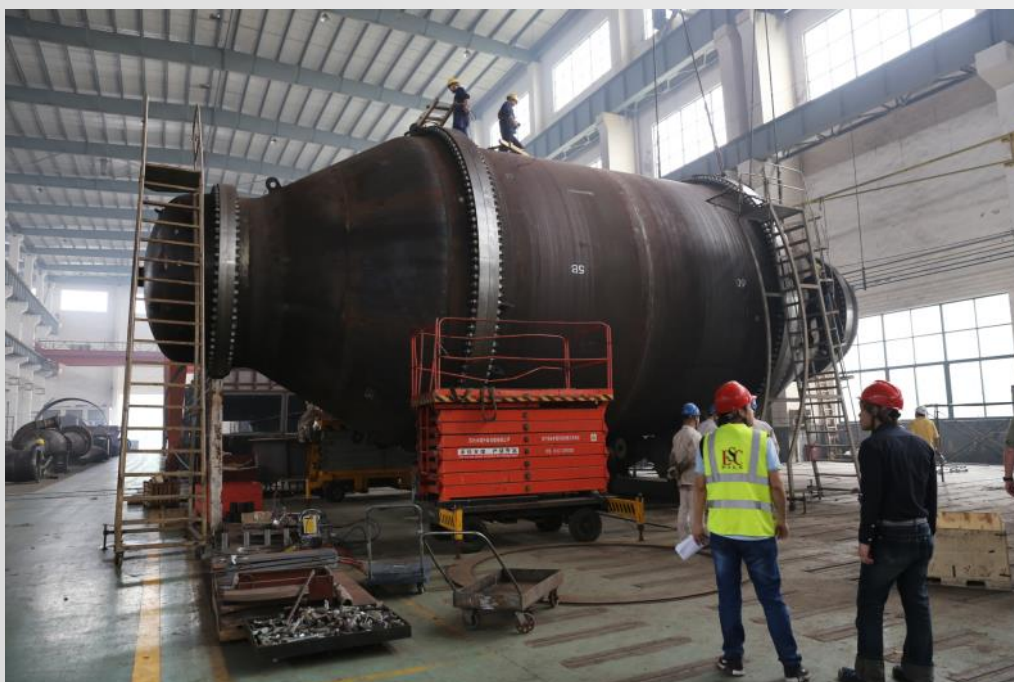
Hydrostatic test pressure equal to 400psi applied gradually for a period not less than 10 minutes at stage 1/3 (133.3psi), 2/3 (266.7psi), and full max pressure (400psi) not less than 60 minutes. The water temperature for the hydrostatic test is controlled to ensure that it is more than 4.5°C. Overall inspection on all welds and sealed surface is carried out at the pressure of 307.69psi to ensure no leakage (check the pressure gage, no pressure drop is allowed).

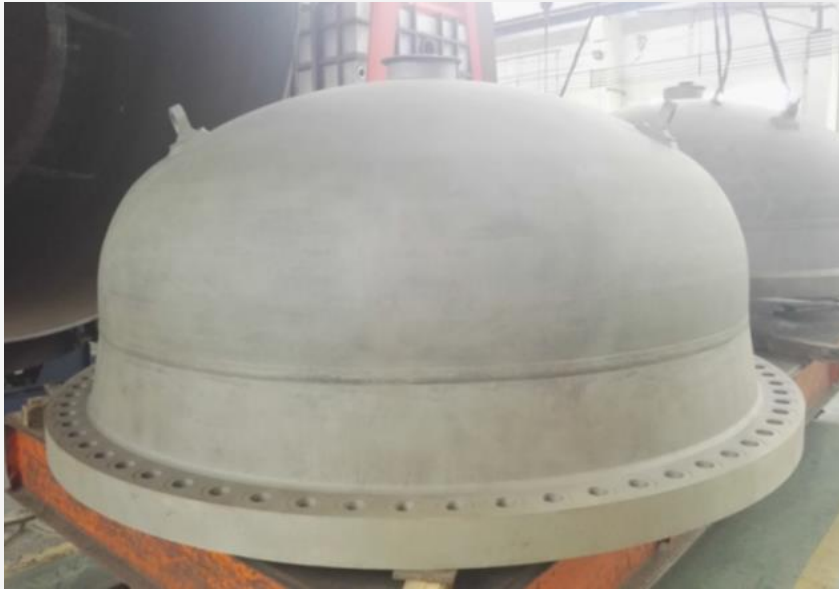
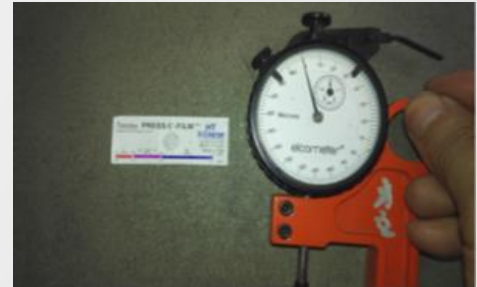
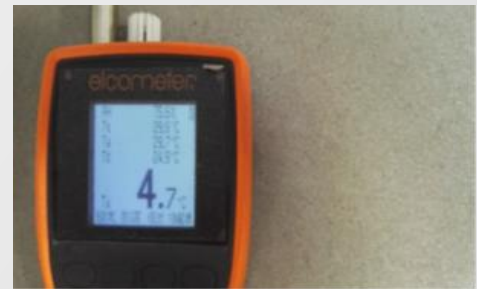
Surface preparation: blasting to Sa2.5, surface roughness inspection, ambient condition inspection, and dust test.

Paint: PPG Amerlock 400 epoxy

Total DFT: 229 ~ 381 μ

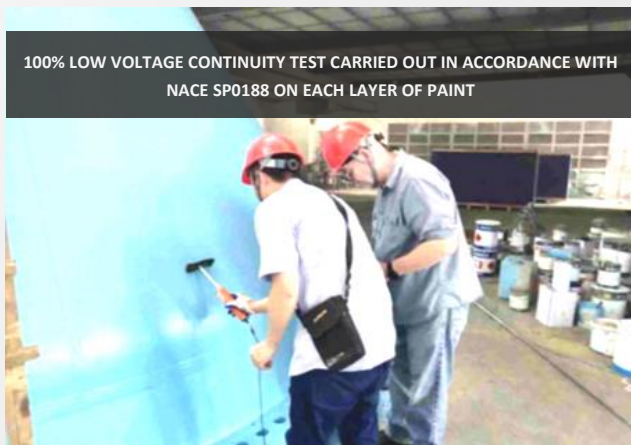
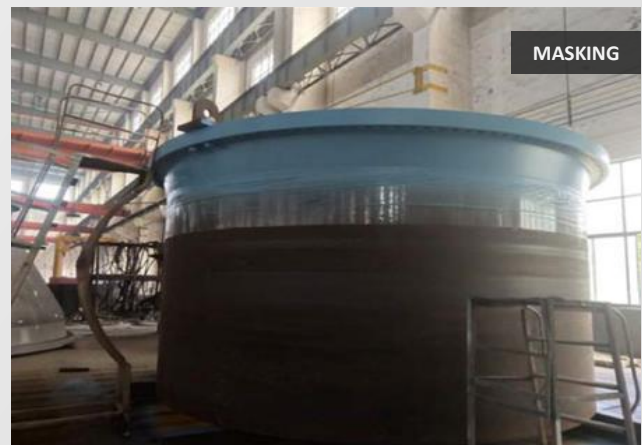
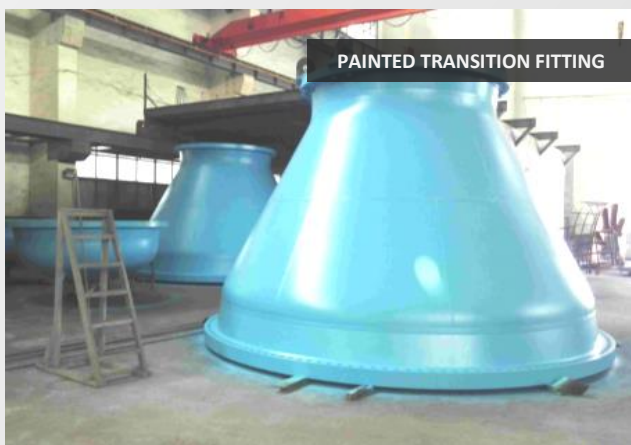
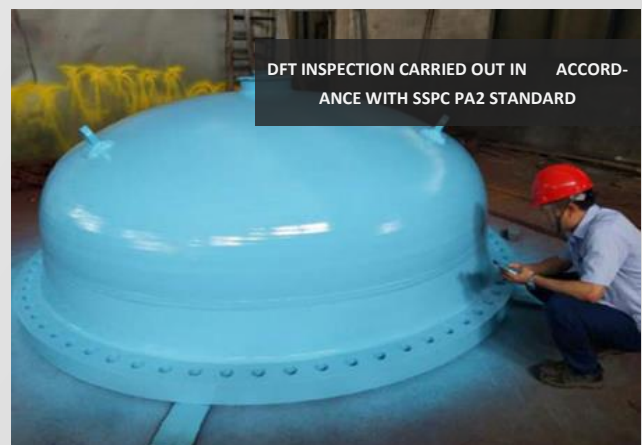
BLASTING & PAINTING

Surface cleanliness: Sa2.5

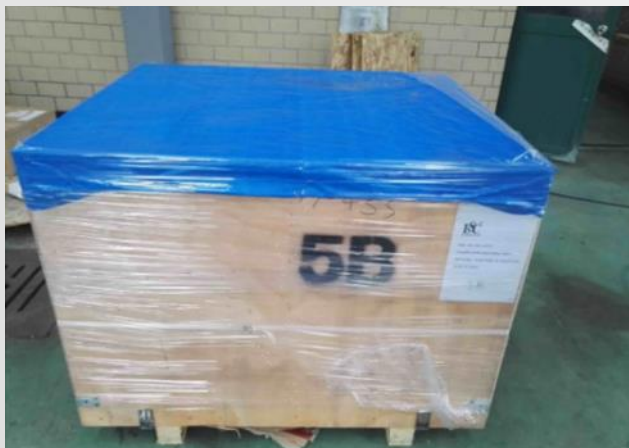
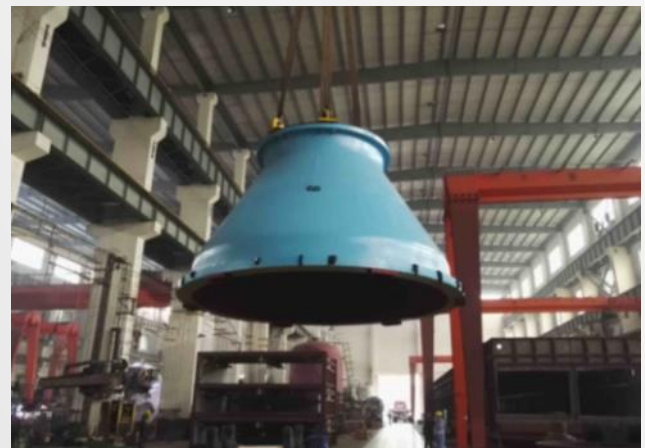
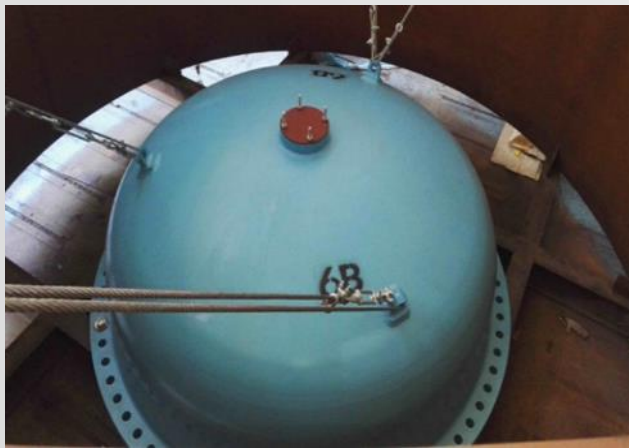
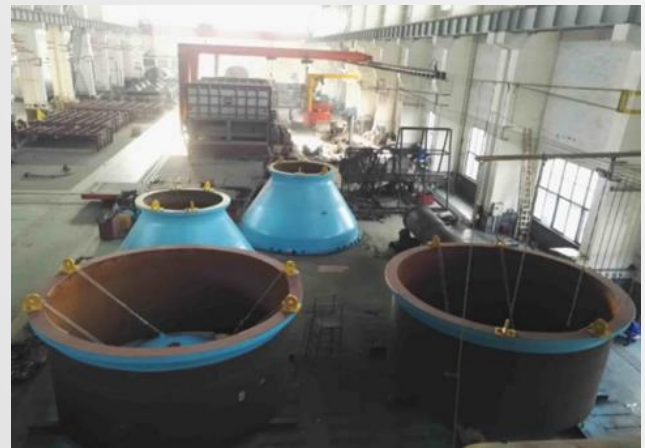
The packing method for each component (base seating for shaft cap and access pipe, lashing method, and lifting lug size) are calculated by the engineer to ensure its is cost effective and safe during the shipping process.

Flanges are protected by bolted plywood covers on each flange after application of slush oil and wrapping with oil impregnated Kraft paper for corrosion protection.
