ORO BRIDGE STRUCTURES

CASE STUDY

Four Bridges - Ambogo River and Eroro River in the Oro province of Papua New Guinea were destroyed by Cyclone Guba in 2007. Construction of the new bridges were scheduled in January 2014.

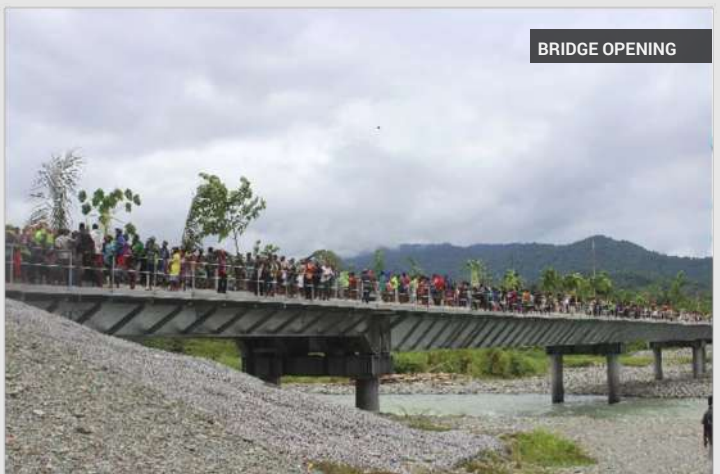
ESC Steel Structures was awarded by Main Contractor Canstruct in Australia to fabricate all steel components for the four bridges. ESC's scope of work was to fabricate over 1,500 tons of steel bridge girders and other components such as elastomeric bearing sets, guard rails, scuppers, edge forms, bracing, splicing plates, channels, lifting lugs and more. The girders were between 1.25 and 2.06 metres high and the lengths were up to 15.0 metres long.

The bridge designs consisted of four steel continuous girders with cast in situ concrete decks. It required a design life and capacity for a 2,000 year flood.
